Quality Assurance and Source Inspection

Contract #: 04-0120F4Cty: SF/ALA Rte: 80 PM: 13.2/13.9File #: 69.28**WELDING INSPECTION REPORT****Resident Engineer:**Pursell, Gary**Address:** 333 Burma Road**City:** Oakland, CA 94607**Report No:** WIR-016001**Date Inspected:** 31-Jul-2010**Project Name:** SAS Superstructure**OSM Arrival Time:** 700**Prime Contractor:** American Bridge/Fluor Enterprises, a JV**OSM Departure Time:** 1900**Contractor:** Zhenhua Port Machinery Company, Ltd (ZPMC), Changxing Island **Location:** Shanghai, China**CWI Name:** Mr. Zhao Chen Sun**CWI Present:** Yes No**Inspected CWI report:** Yes No N/A**Rod Oven in Use:** Yes No N/A**Electrode to specification:** Yes No N/A**Weld Procedures Followed:** Yes No N/A**Qualified Welders:** Yes No N/A**Verified Joint Fit-up:** Yes No N/A**Approved Drawings:** Yes No N/A**Approved WPS:** Yes No N/A**Delayed / Cancelled:** Yes No N/A**Bridge No:** 34-0006**Component:** Tower**Summary of Items Observed:**

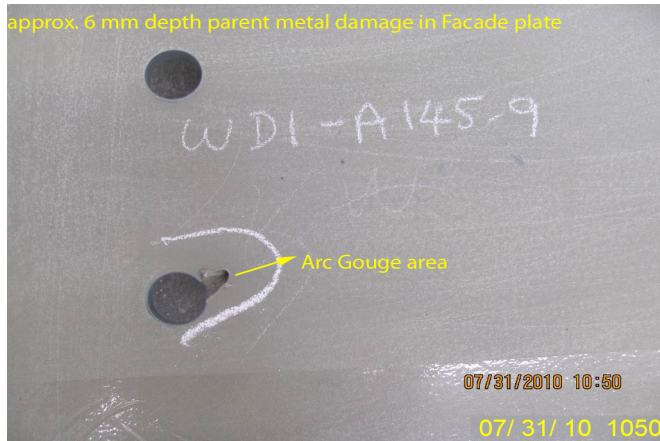
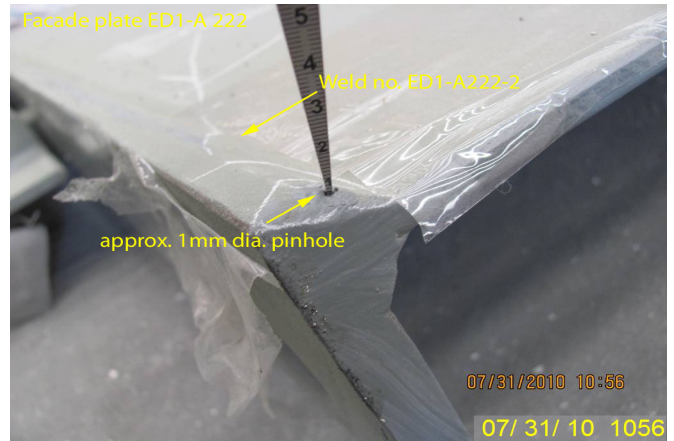
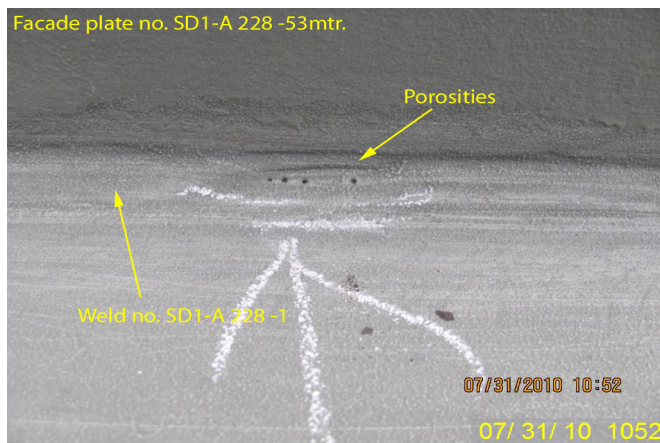
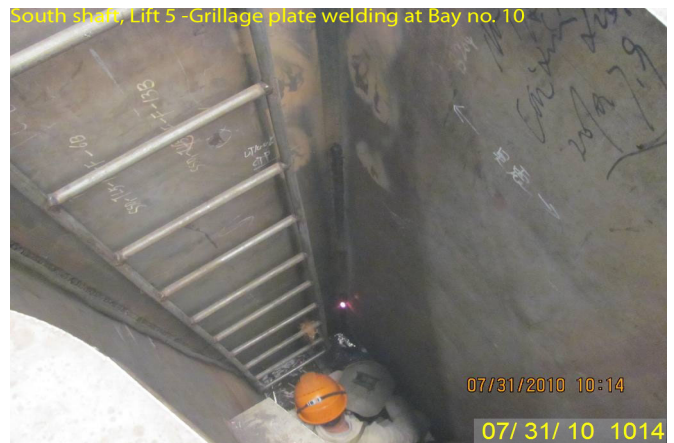
7.This QA inspector, Baskar Govindarajan, observed, porosities, pinhole and Base metal damage in Façade plates SD1-A228 -53 mtr., ED1-A222 and WD1-A145 respectively. Taped all weld repair areas and wrote incident report for tracking the same. Photo of Porosity, pinhole and Base metal repair is attached.
